An Evaluation of the Long Term Bridge Performance Program

ABSTRACT

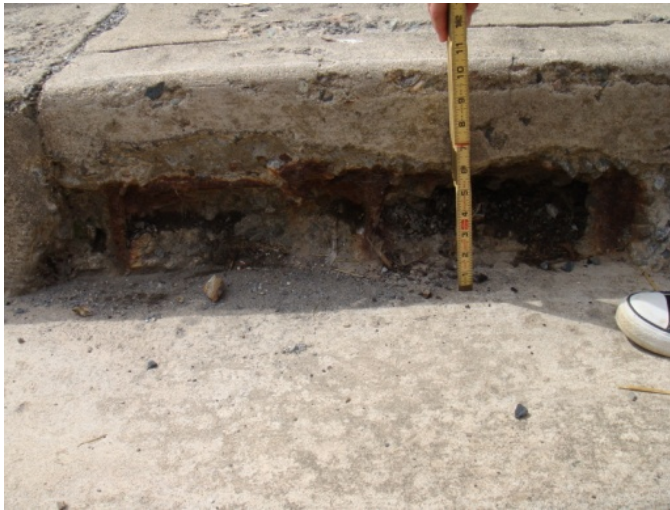
Figure 1.0

The embankment, which exhibited stable soil and foliage and did not display signs of erosion, was assigned a rating of 8, while the settlement was assigned a rating of 7. On the northeast and southeast corners of the bridge, a settlement of 2.5 inches was apparent between the approach and bridge deck. Also, the pavement was assigned a rating of 6. It contained spalled and cracked areas, although these deteriorated areas had undergone minor repairs. The guide railing was in good condition and was assigned a rating of 8. The railing did not exhibit any dents, breaks, or deteriorated portions.

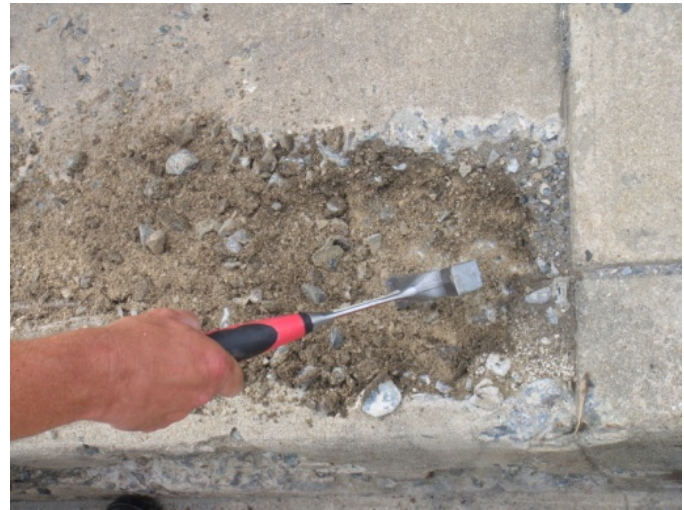
The wearing surface and deck structural were assigned a rating of 7. The surface of the deck exhibited only a few small, minor cracks and overall did not display any significant signs of deterioration and damage. The curbs, sidewalks, and fascias were in worse condition and were assigned a rating of 5. The concrete of these elements exhibited corrosion and spalling in several areas. A relatively significant case of spalling was located on a northern curb and was 30 inches long, 6 inches high, and 3 inches deep. (see Figure 1.0) In addition, there was a settlement of about 3 inches between the curb and the bridge deck. The members and joints of the bridge were observed to be in good condition and did not exhibit significant signs of deterioration or damage and thus were assigned a rating of 7. Additionally, the paint was given a rating of 8, as it appeared to be in almost new condition, with no indicators of peeling, cracking, discoloration, or corrosion.
